Manhole Inspection Summary

Manhole # S25A__003MH

Insp Date: **8/20/07 9:12 AM**

Location Address: **1208 EDMONDSON AVE**

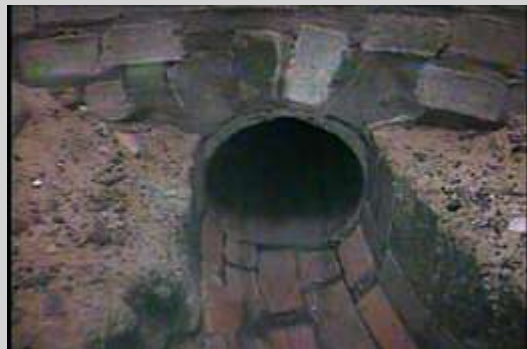
8 O'Clock Inflow

8 in. Circular Gravity Sewer
Pipe In @ 8 O'Clock

Pipe Height: **8.4** (in.) Rod and Bar (Angled)

Pipe Material: **Clay** ☐ Pipe Lined

Infiltration: **None** Pipe Seal Cond: **Sound**
